Building 124 and 129 Close Out Report

Description of Operations, Functions and Closure

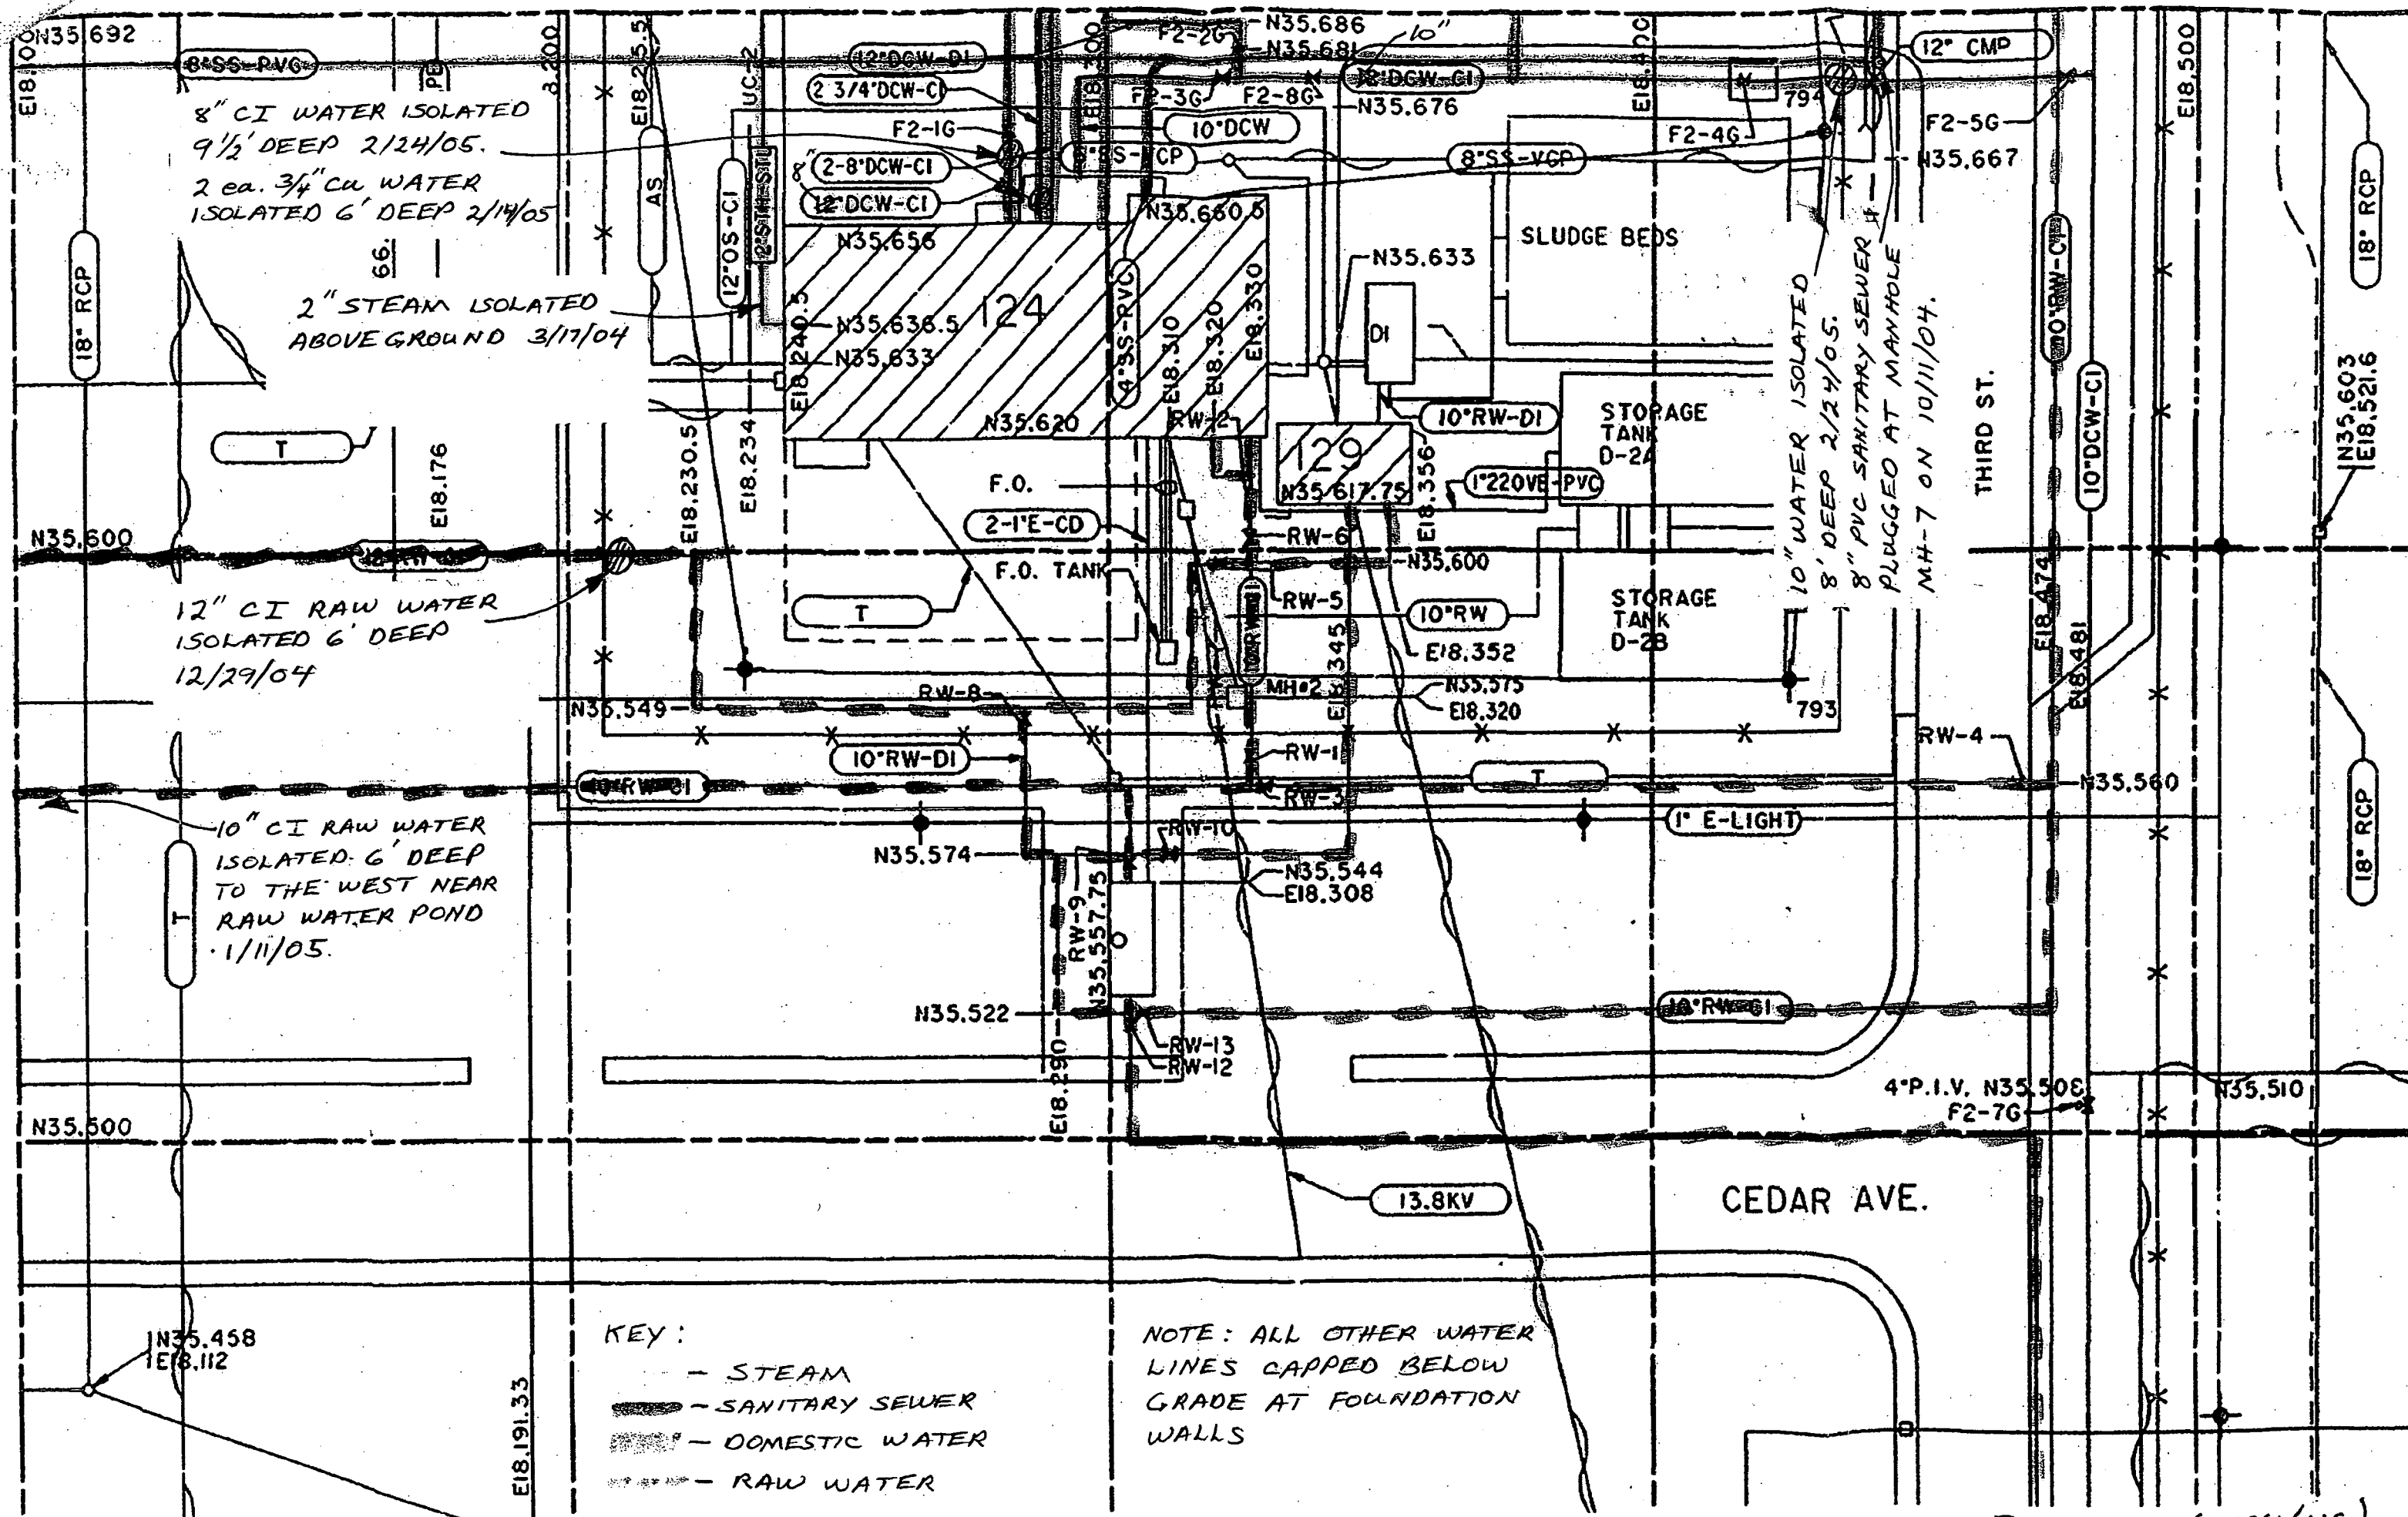
Figure 3
B124 and B129 Close Out Report
Remaining Infrastructure

of the building prior to demolition. The sanitary collection system included a 6 inch line that ran from B124 eastward and a manhole along the east side of the B124 area; the manhole was grouted and removed to 4 feet bfg. Figure 3 shows the remaining infrastructure at the end of demolition.
